NATIONAL ADVISORY COMMITTEE FOR AERONAUTICS

No. 1573

FLIGHT MEASUREMENTS OF THE FLYING QUALITIES OF
FIVE LIGHT AIRPLANES

By Paul A. Hunter

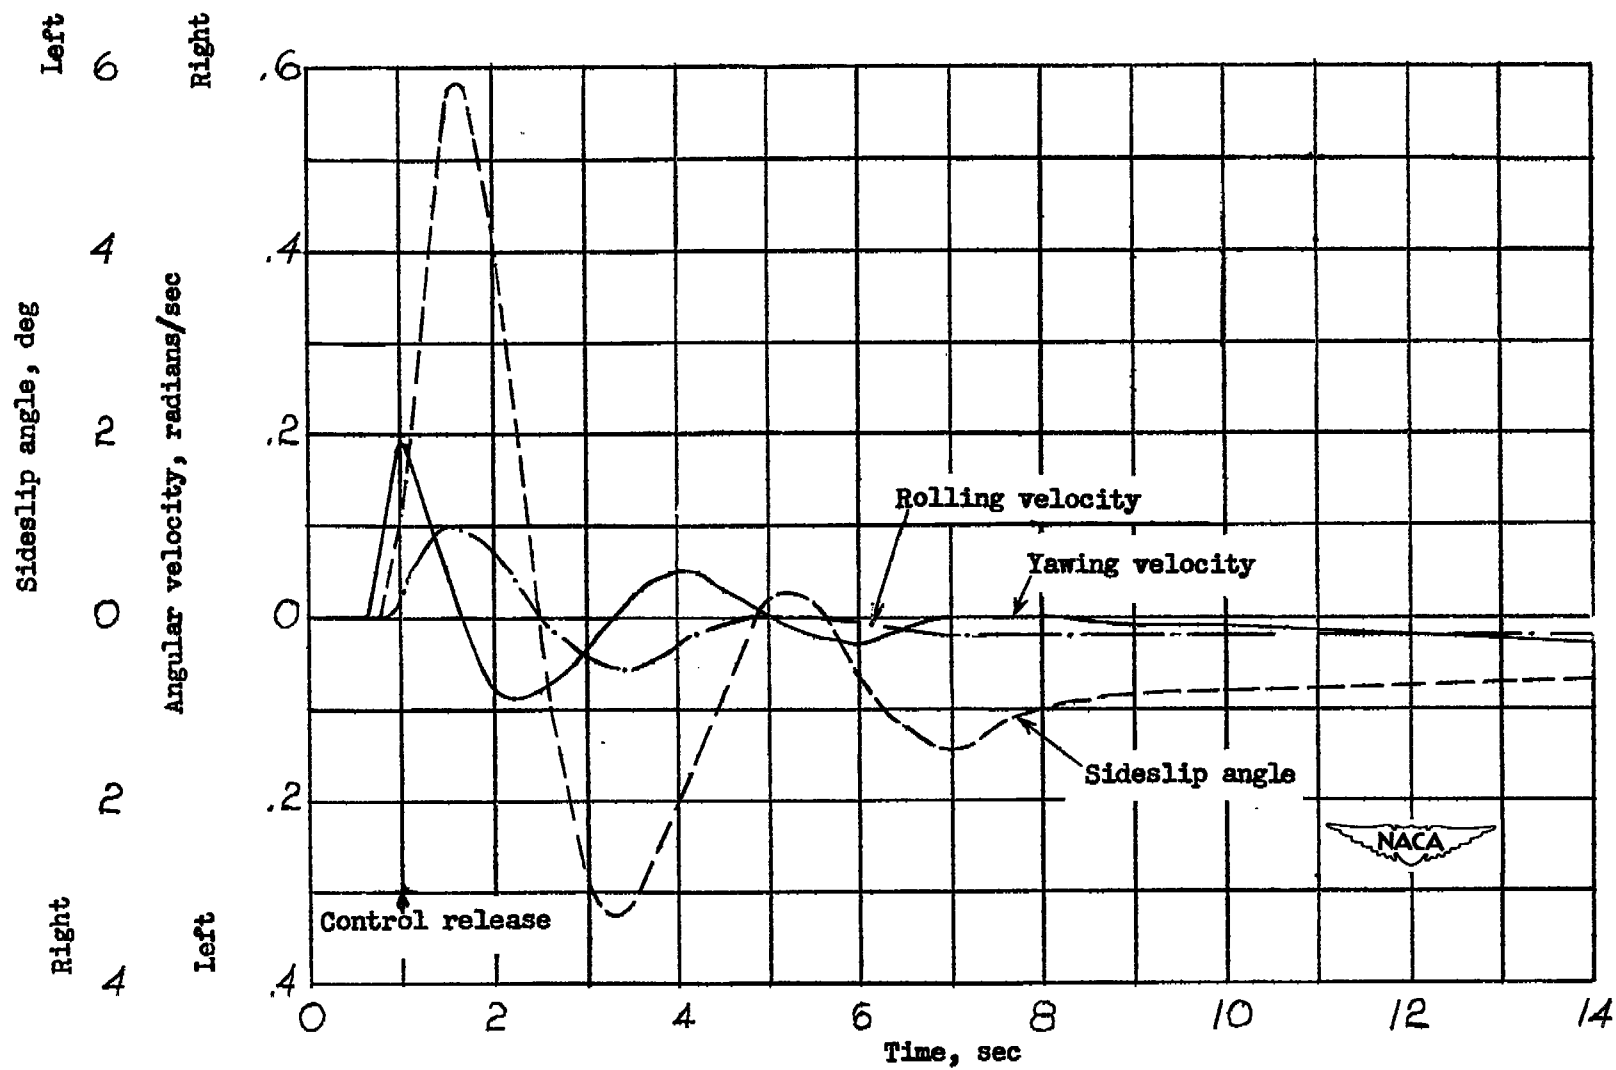
Figure 13.- Relation between yawing velocity, rolling velocity, and sideslip angle in a typical lateral oscillation with power on and flaps up. Airplane 4.

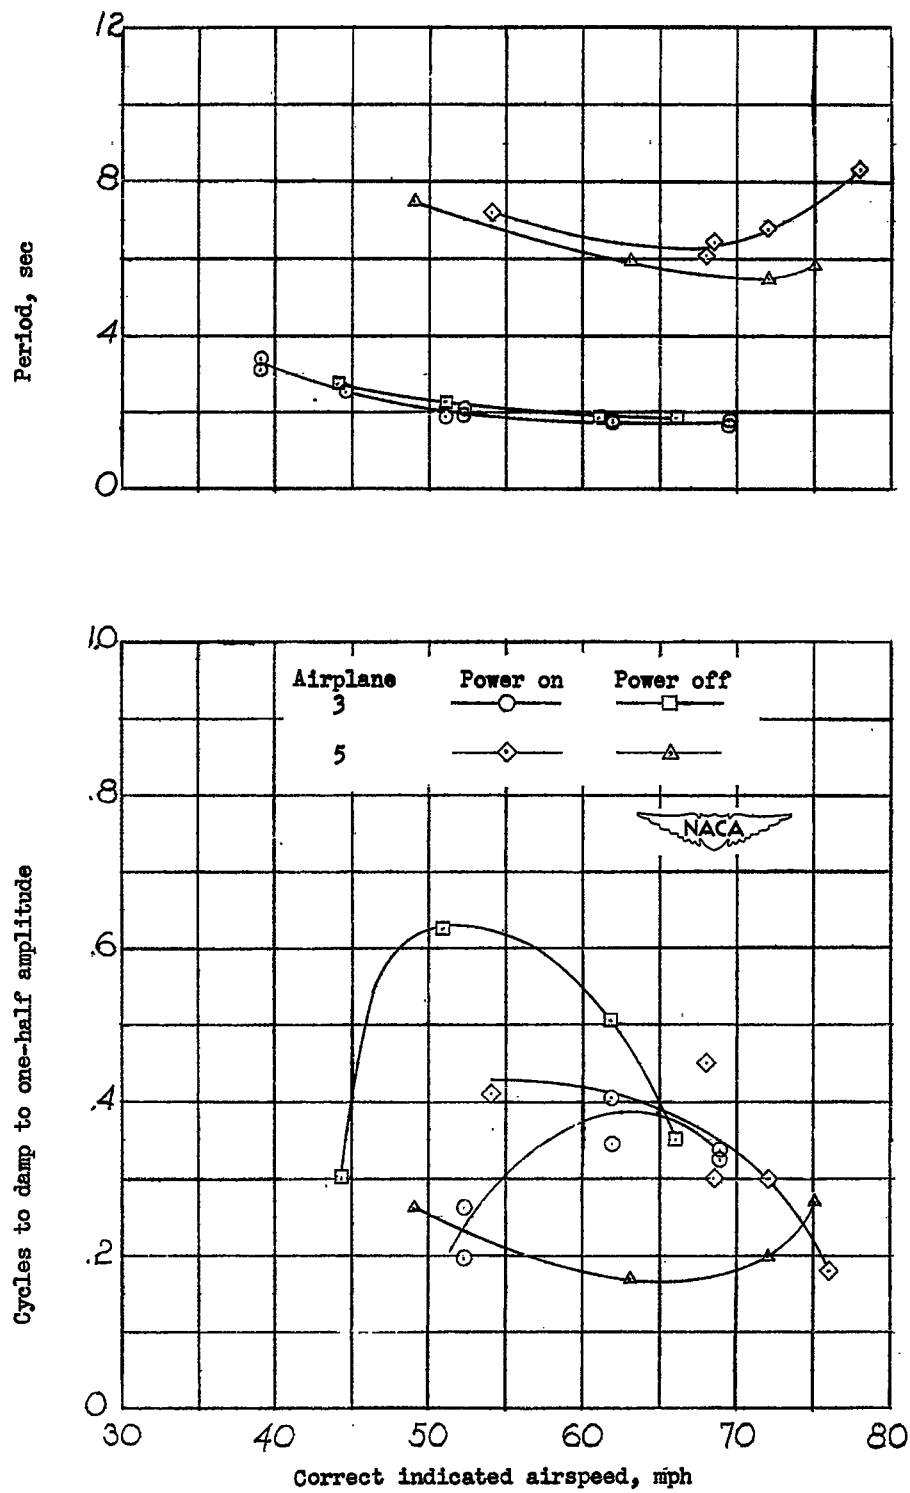
Figure 14.- Period and damping characteristics for lateral oscillations. Airplanes 3 and 5.

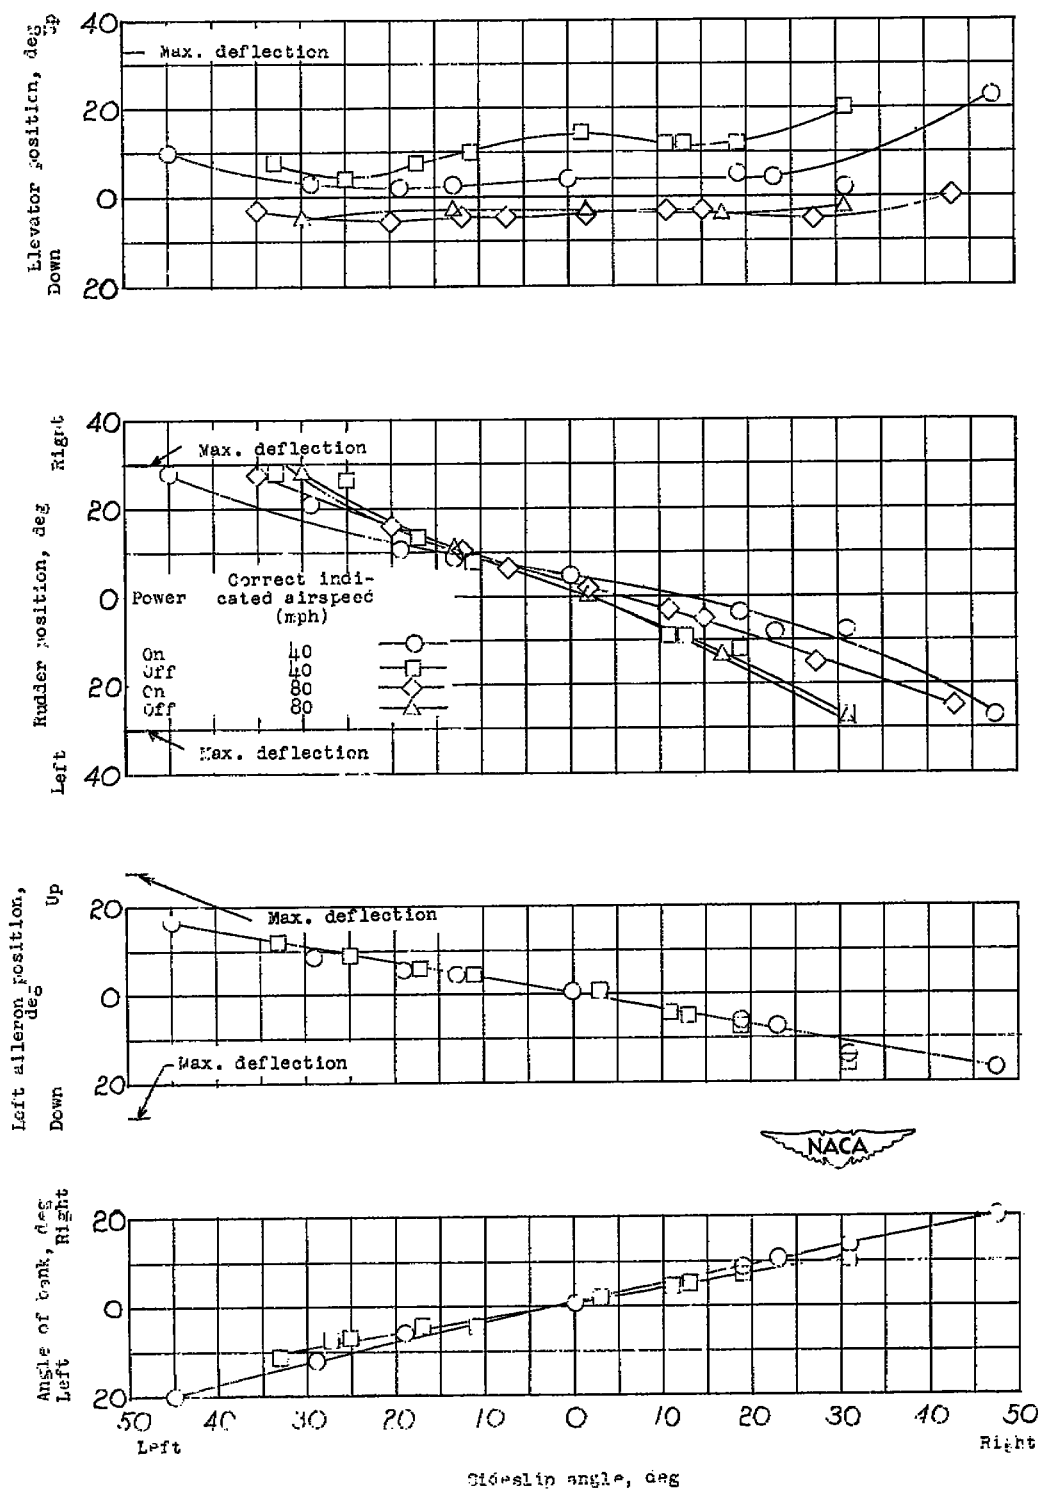
Figure 15.- Sideslip characteristics. Airplane 1.

for example, during recovery from an improperly coordinated turn. Figures 15 to 19 show that considerable differences in pitching-moment characteristics existed among these five airplanes although the change in pitching moment with sideslip was generally desirably small. In most cases the pitching moment was such as to cause the airplane to nose down at large sideslip angles although some airplanes which were in this classification also showed a tendency to nose up at small angles of sideslip. These two characteristics may be seen in figure 15 for airplane 1 in the power-on low-speed and power-off low-speed conditions, respectively. Airplane 4 in most cases tended to pitch up at large angles of sideslip, as may be seen in figure 18. Unsymmetrical pitching-moment characteristics are shown in figure 15 for airplane 1 in the power-off high-speed condition and in figure 19 for airplane 5 in the power-off low-speed condition. This type of characteristic is not particularly dangerous but is somewhat unusual in the power-off condition. The particular pitching-moment characteristic noted in the low-speed condition for a given configuration and airplane was generally encountered also at the higher speeds but the magnitudes were smaller. Airplane 2 showed little change in pitching moment with sideslip angle relative to that of the other airplanes, mainly because of the small sideslip angle attainable with this airplane. Because these tests were made by keeping the pilot's airspeed meter reading constant, these data are not entirely satisfactory, since considerable error was introduced in the airspeed system by sideslip on the pitot-static head. Partial stalling may have occurred during the low-speed power-off sideslips and may have introduced further error in the data.

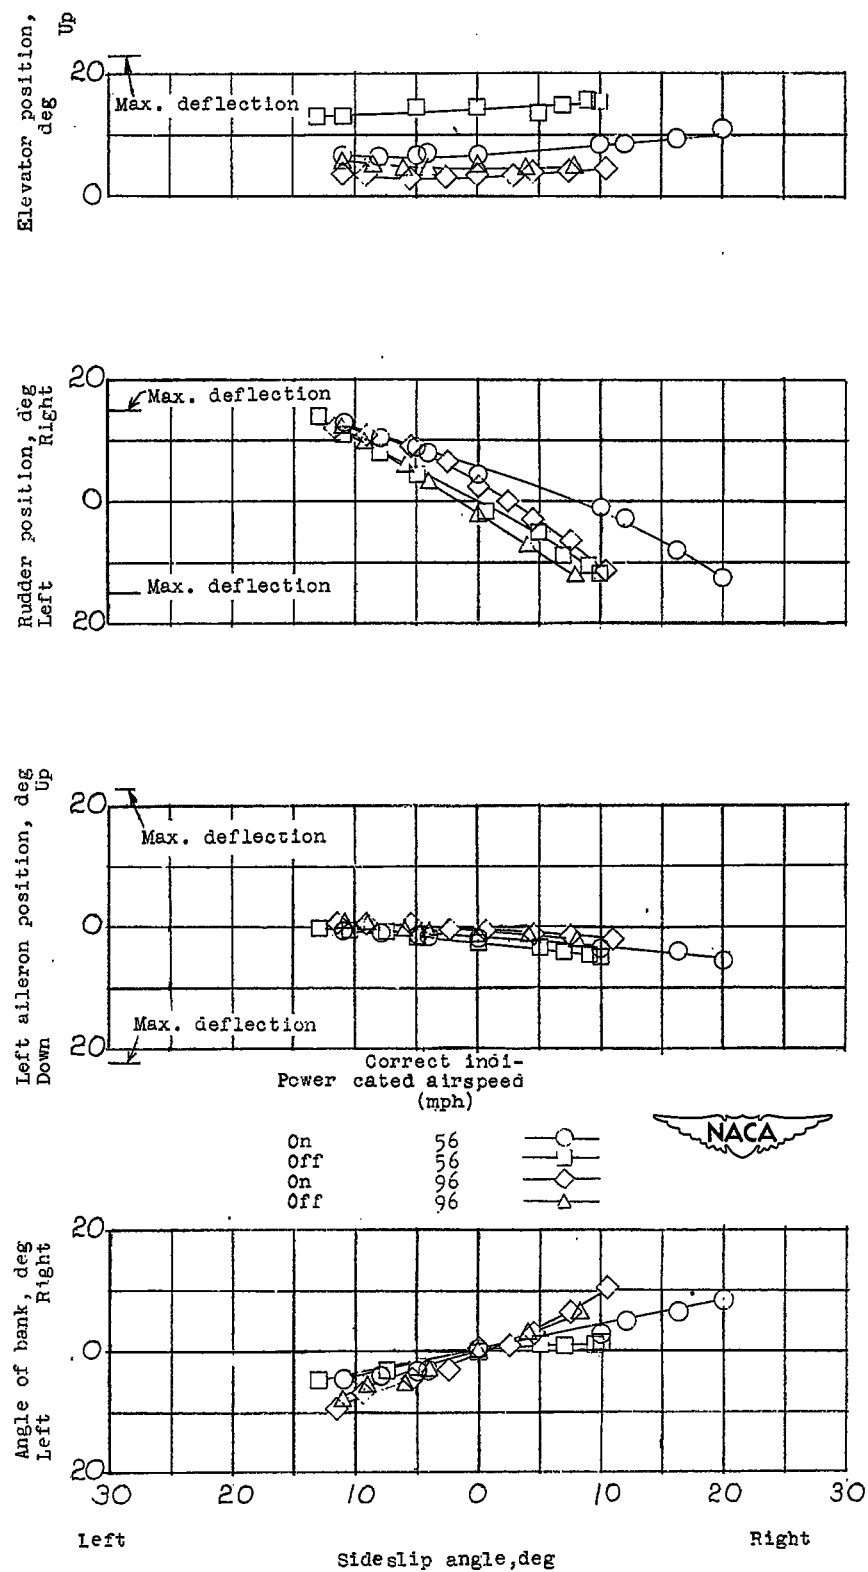
Figure 16.- Sideslip characteristics. Landing gear down; airplane 2.

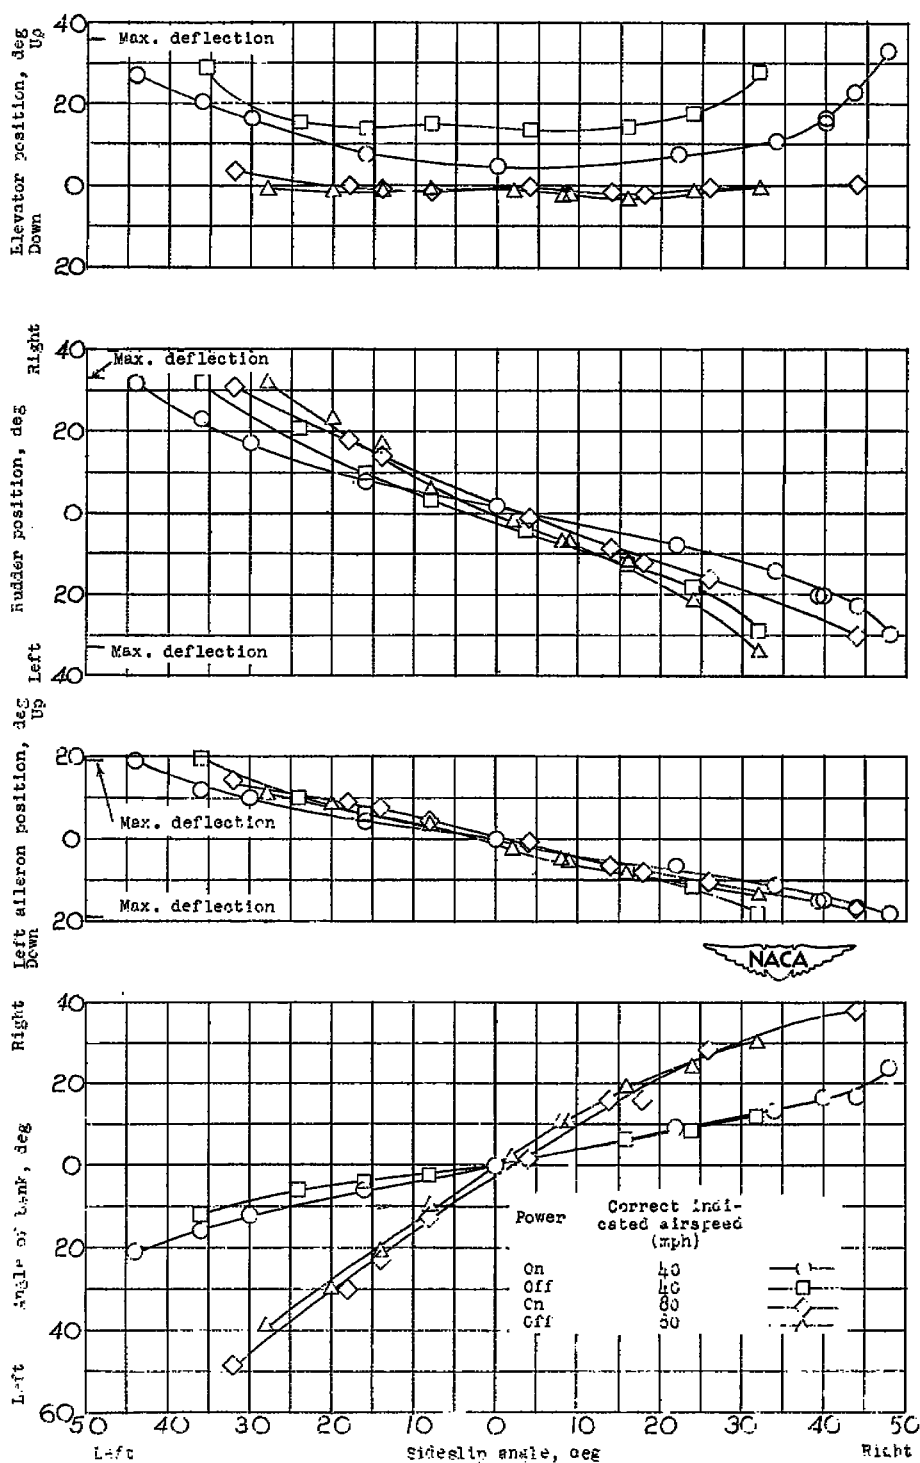
Figure 17.- Sideslip characteristics. Airplane 3.

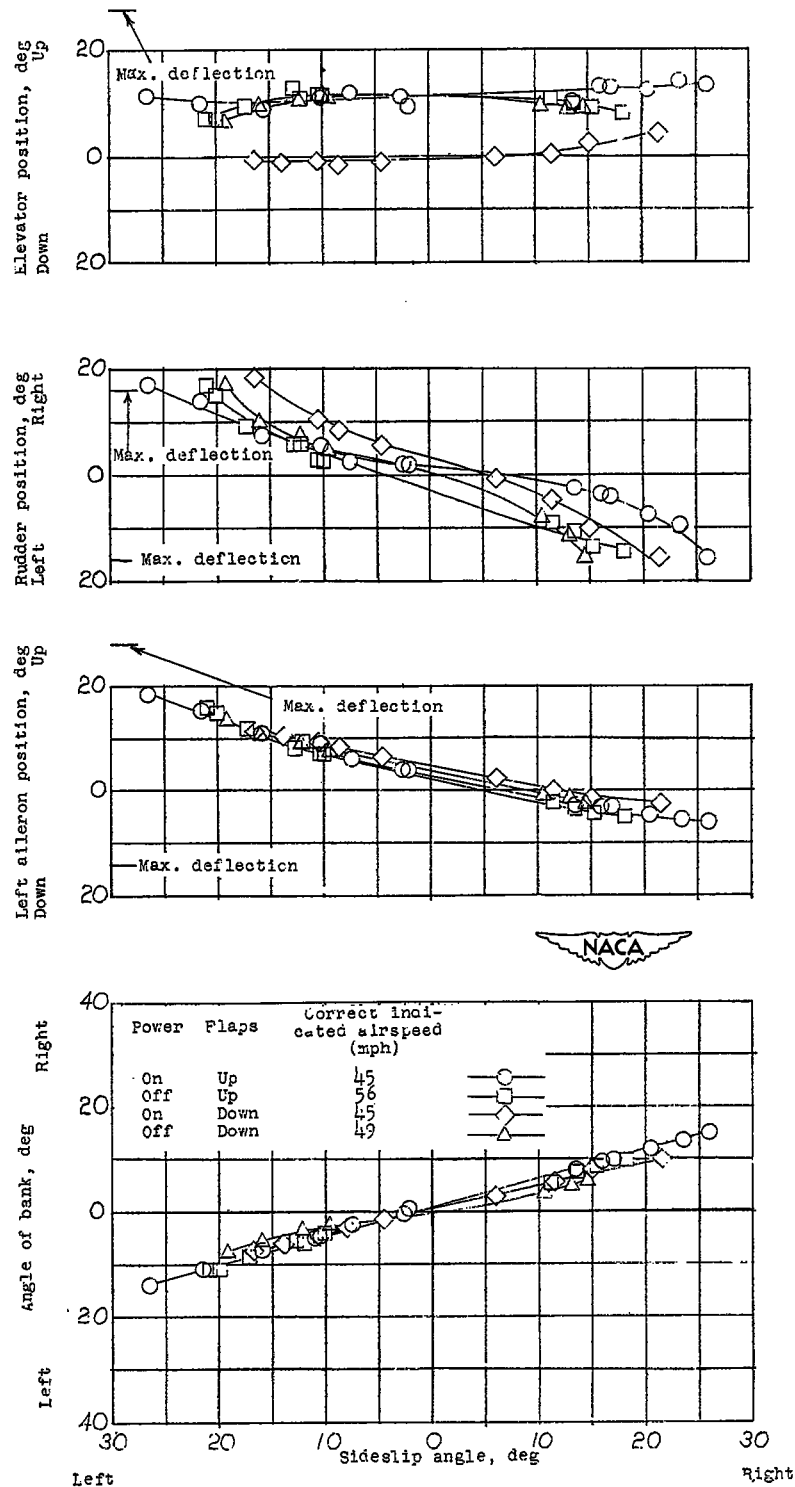
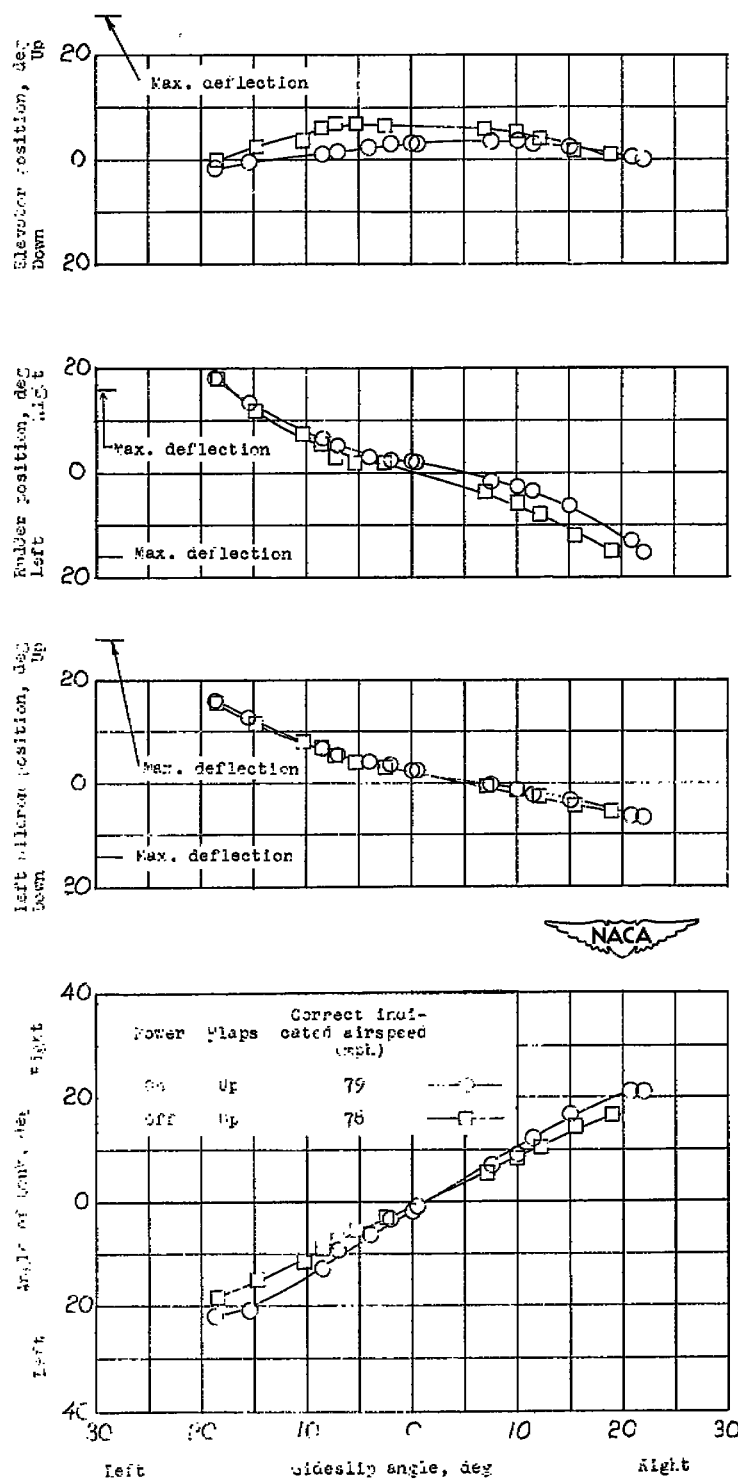
(a) Low speed.

Figure 18.- Sideslip characteristics. Airplane 4.

(b) High speed.

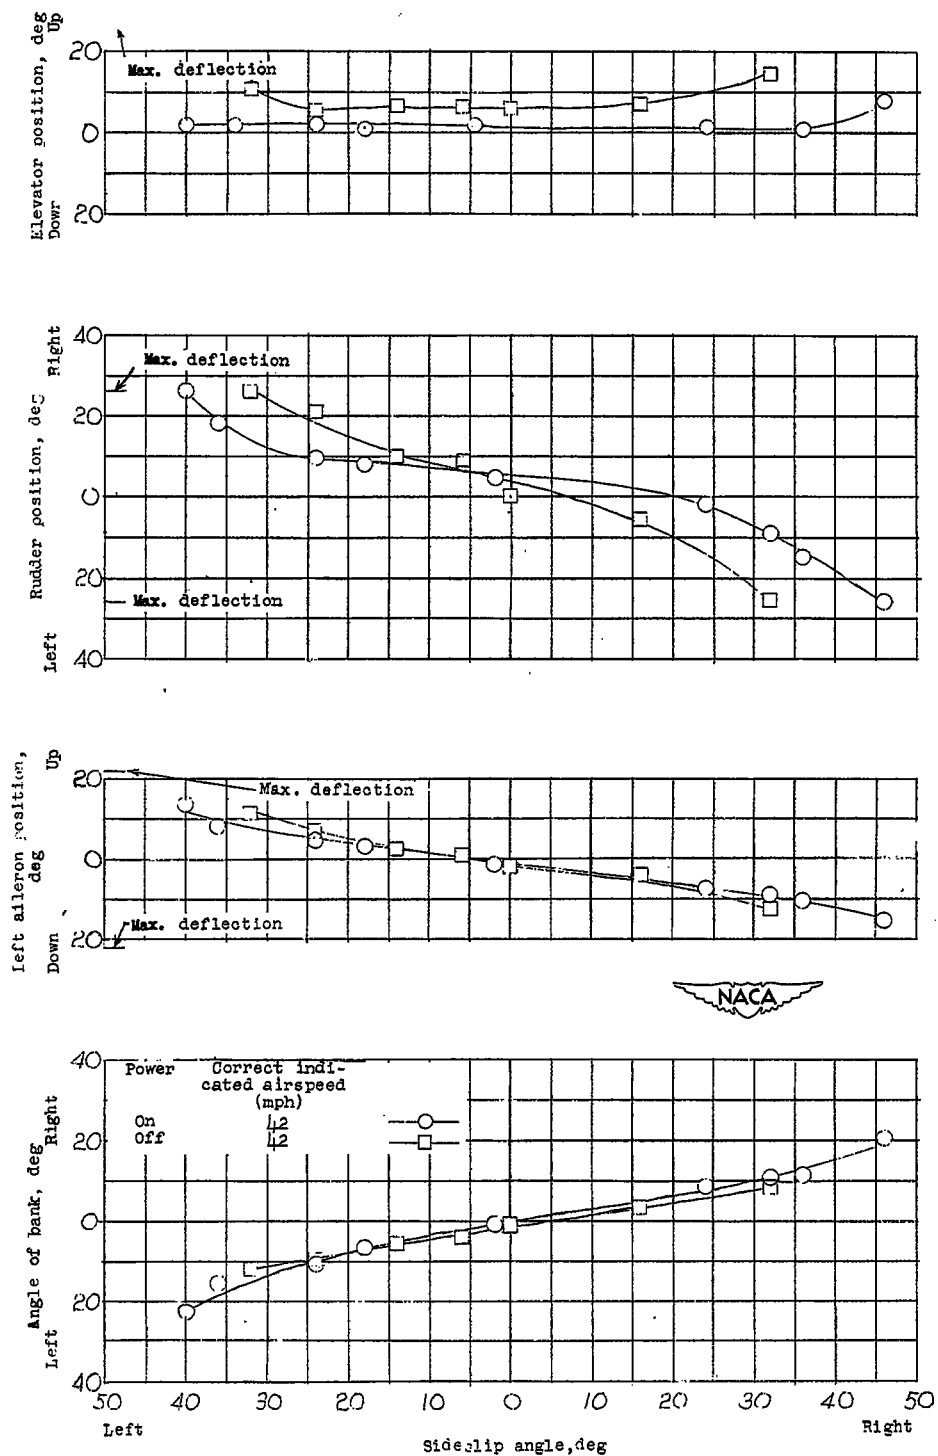
Figure 19.- Sideslip characteristics. Airplane 5.

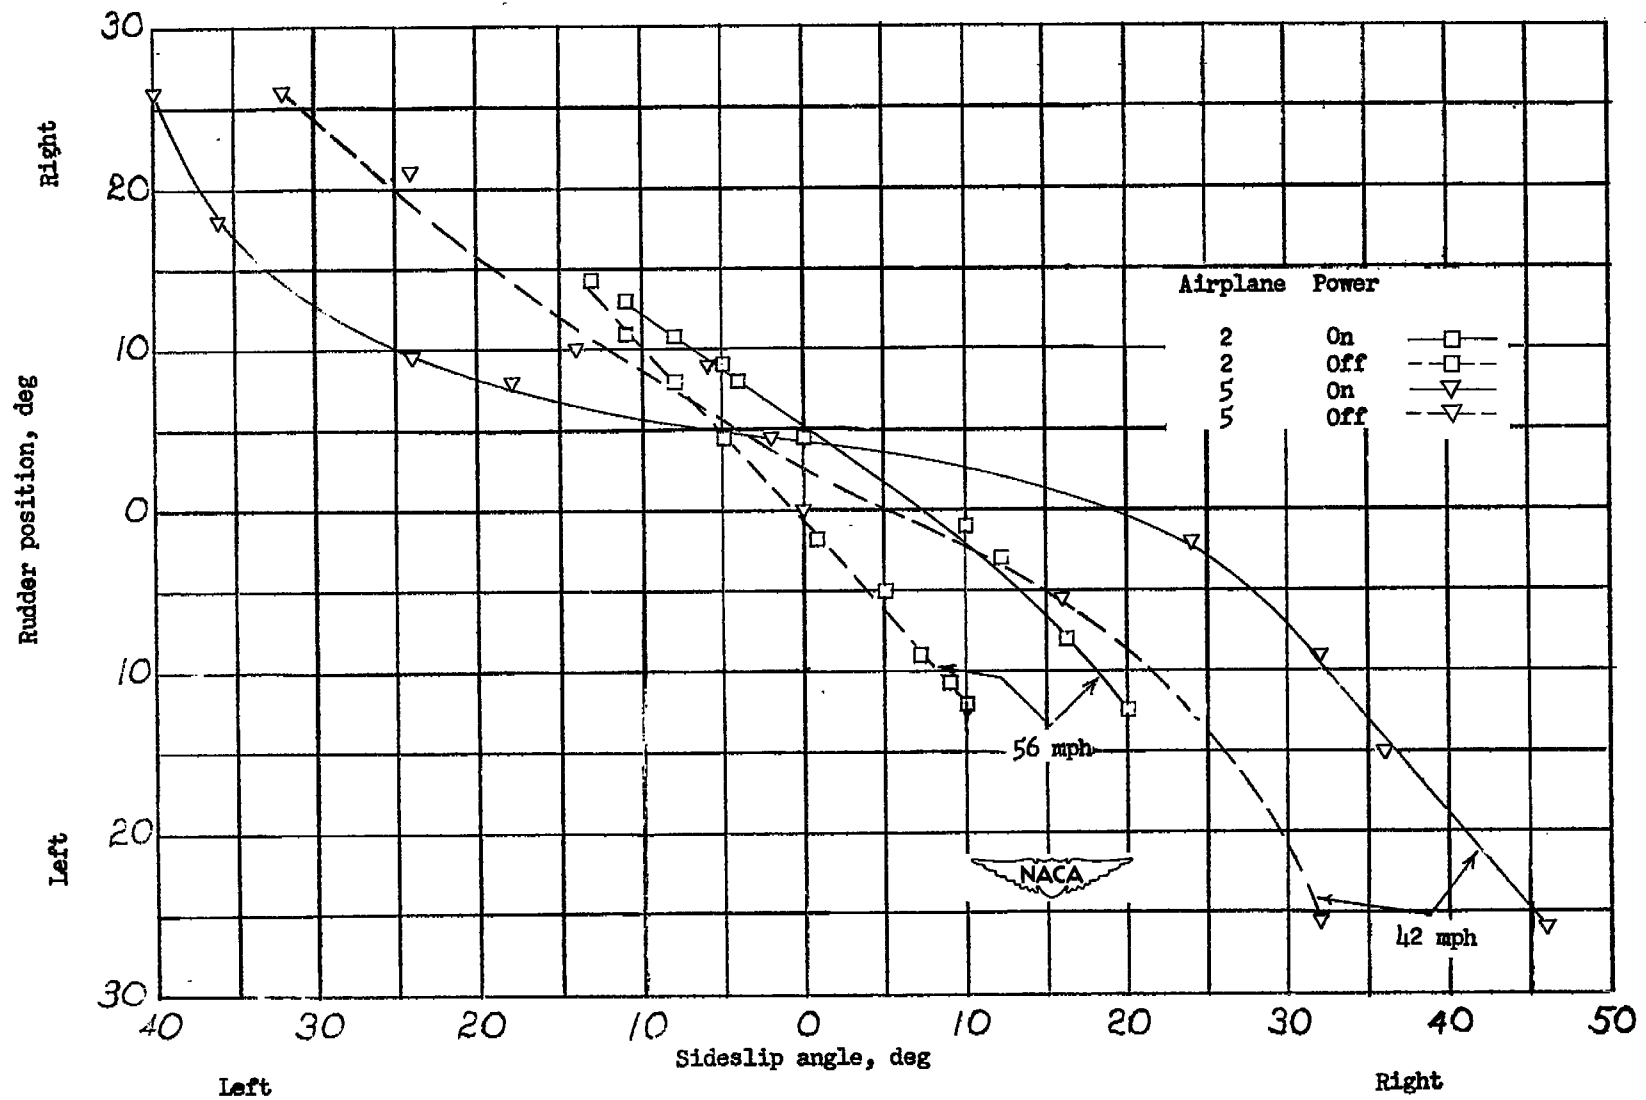
Figure 20.- Relative directional stability of two of the airplanes tested. Airplanes 2 and 5.

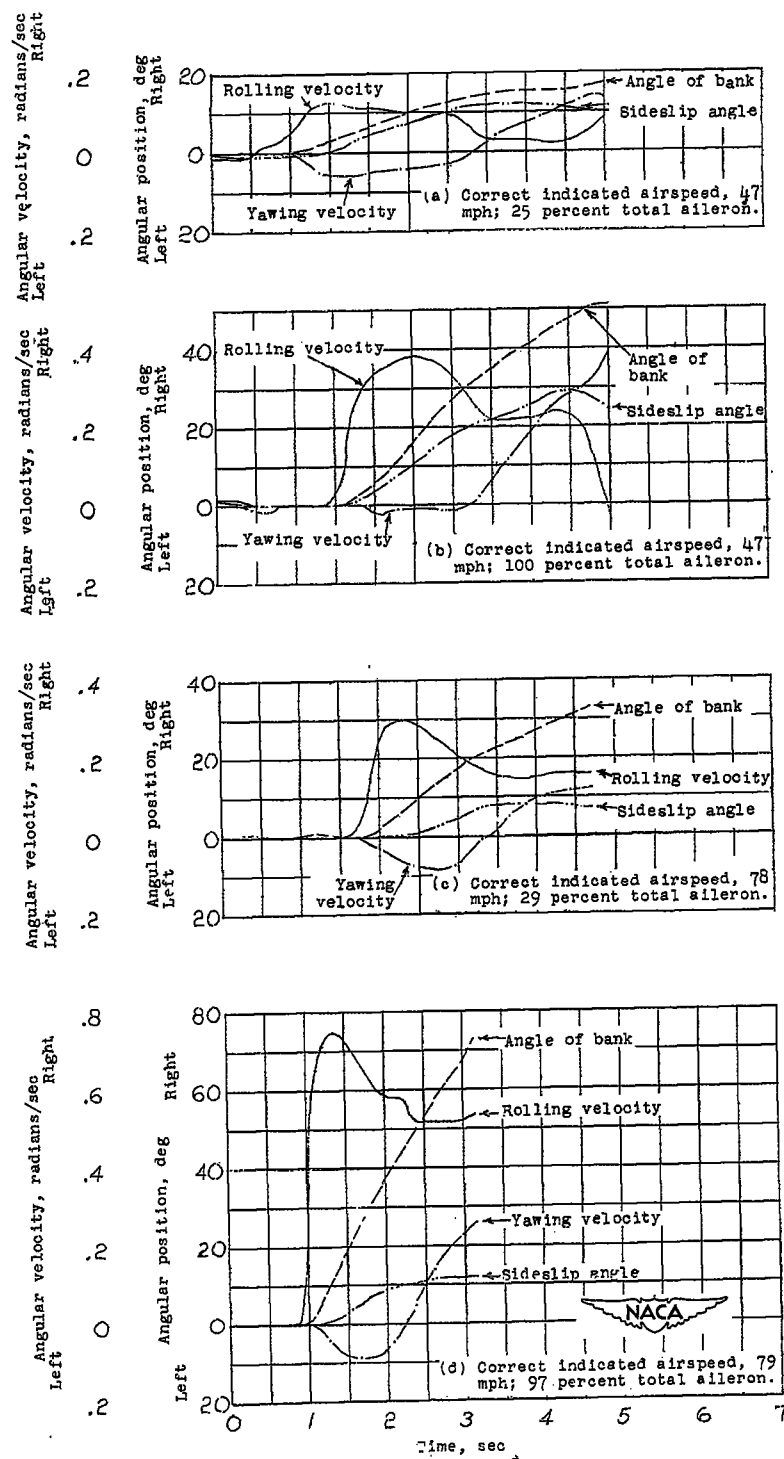
Figure 21.- Time histories of four aileron rolls. Power off; flaps up; airplane 4.

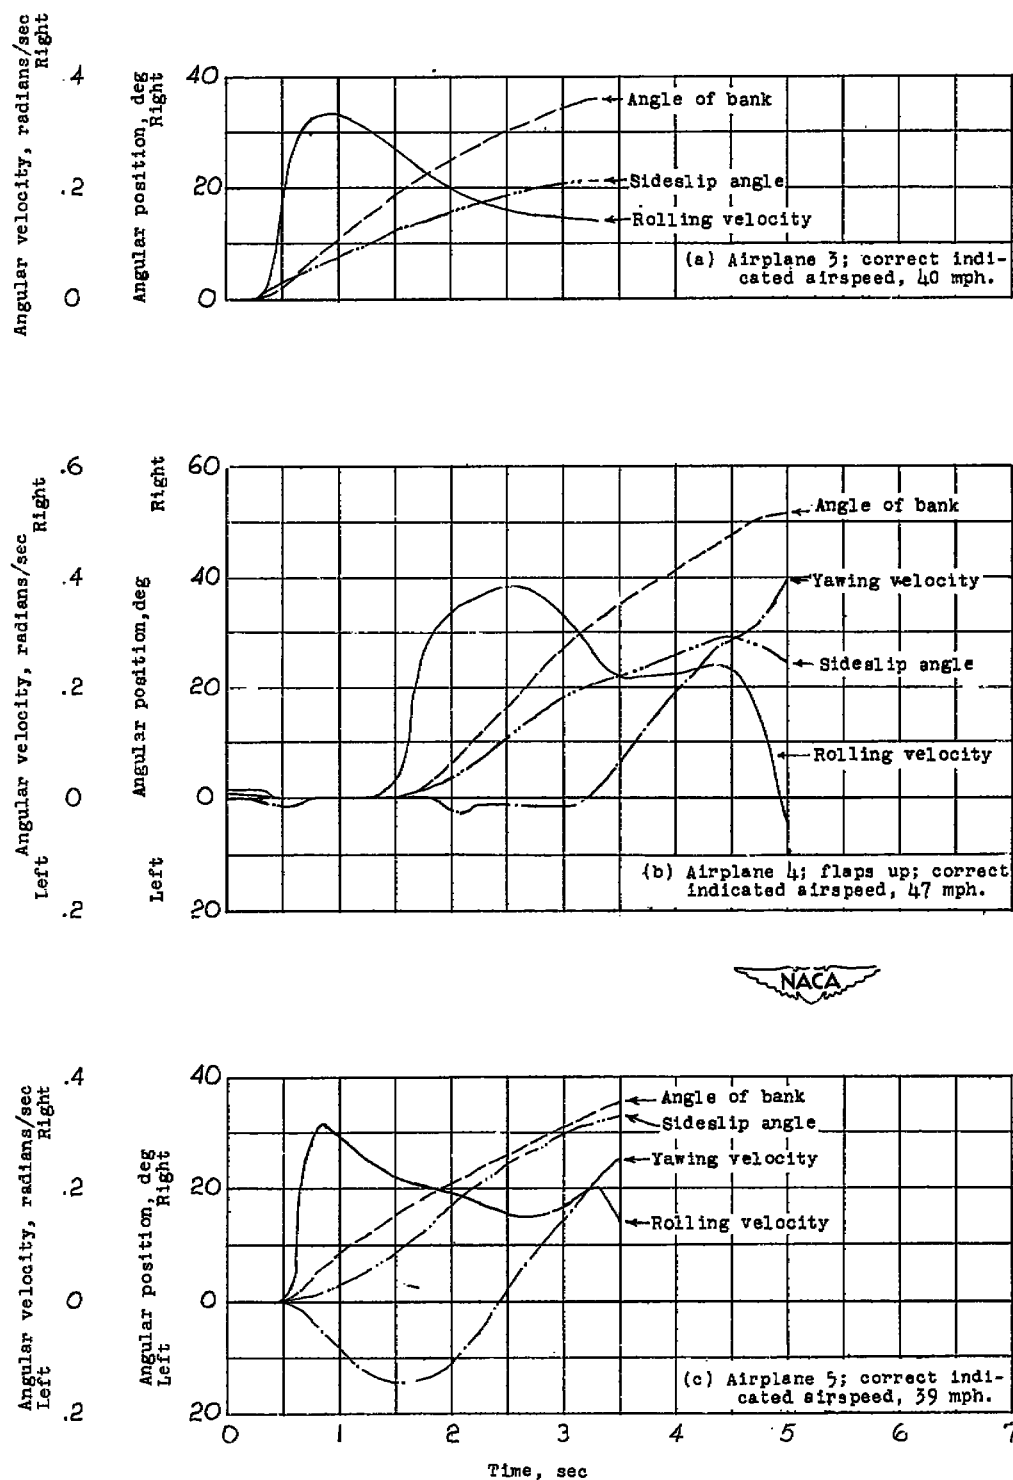
Figure 22.- Time histories of aileron rolls at low speed and full aileron for three airplanes with power off.

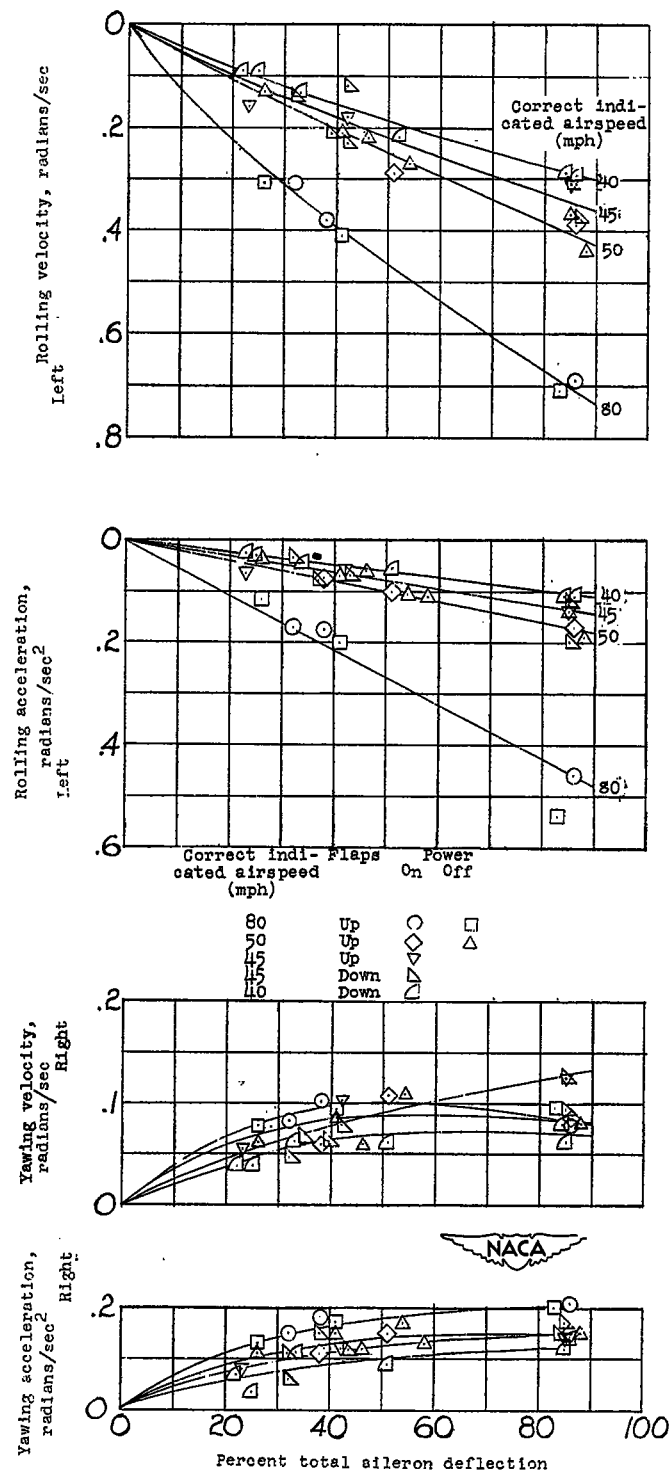
Figure 23.- Aileron characteristics. Airplane 4.

The magnitudes of the rolling accelerations shown in figure 23 are of interest mainly from structural considerations, although the ratio of the rolling acceleration to yawing acceleration is of interest as a measure of the adverse yaw. Changes in power or flap condition for airplane 4 are seen from figure 23 to have no appreciable effect on the aileron characteristics. Likewise, landing-gear position had a negligible effect on the aileron characteristics of airplane 2.

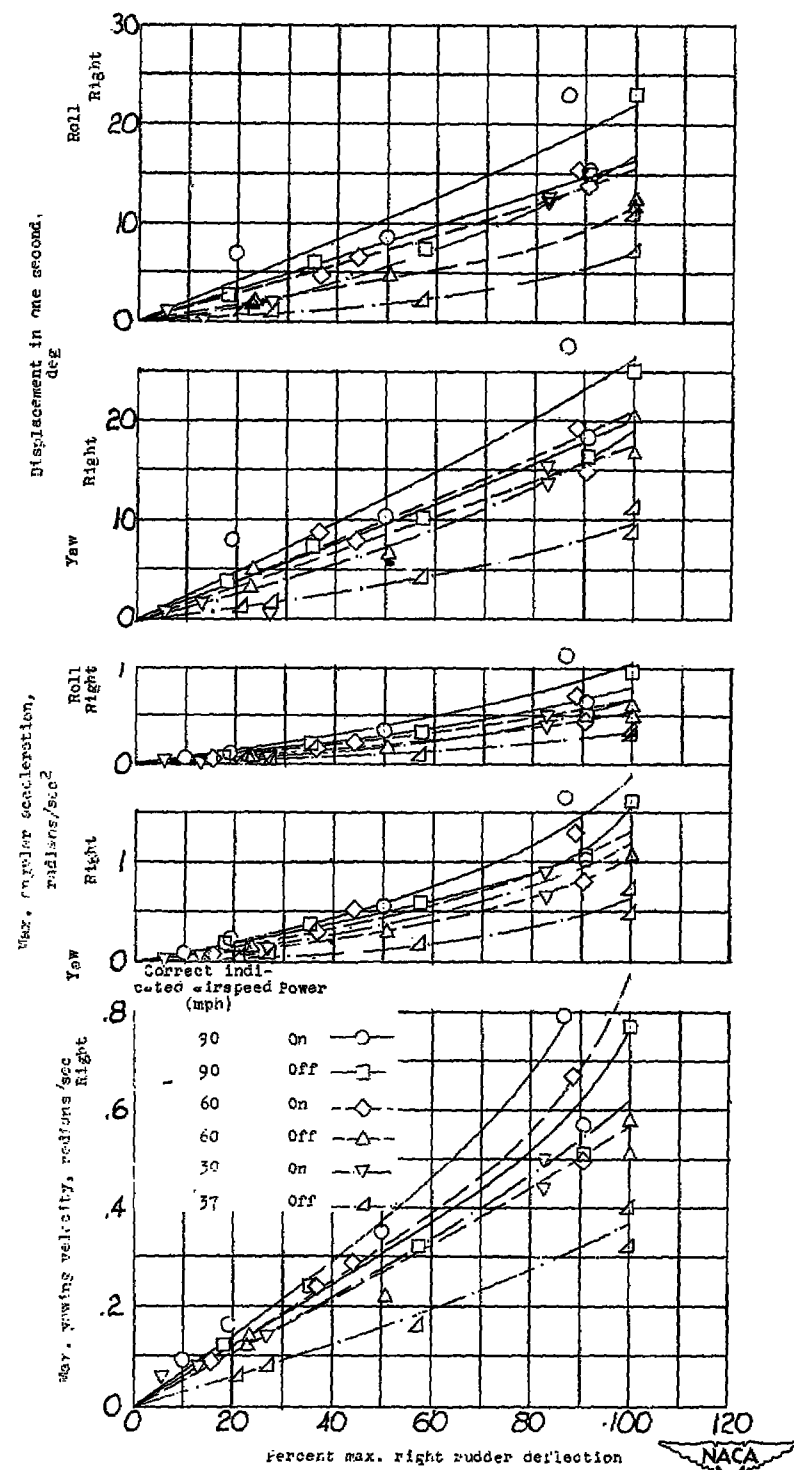
Figure 24.- The maximum yawing velocities, yawing and rolling accelerations, and displacements in yaw and roll produced by abrupt rudder deflections at various speeds. Airplane 1.

The rudder-kick maneuvers shown in figure 24 for airplane 1 indicated a positive dihedral effect in all conditions, as did the sideslip tests, the displacements in roll and rolling accelerations always being to the right for right rudder deflections. The magnitude of the roll due to rudder was in no condition considered to be excessive by the pilot. This conclusion was reached for all airplanes where roll due to rudder was measured.

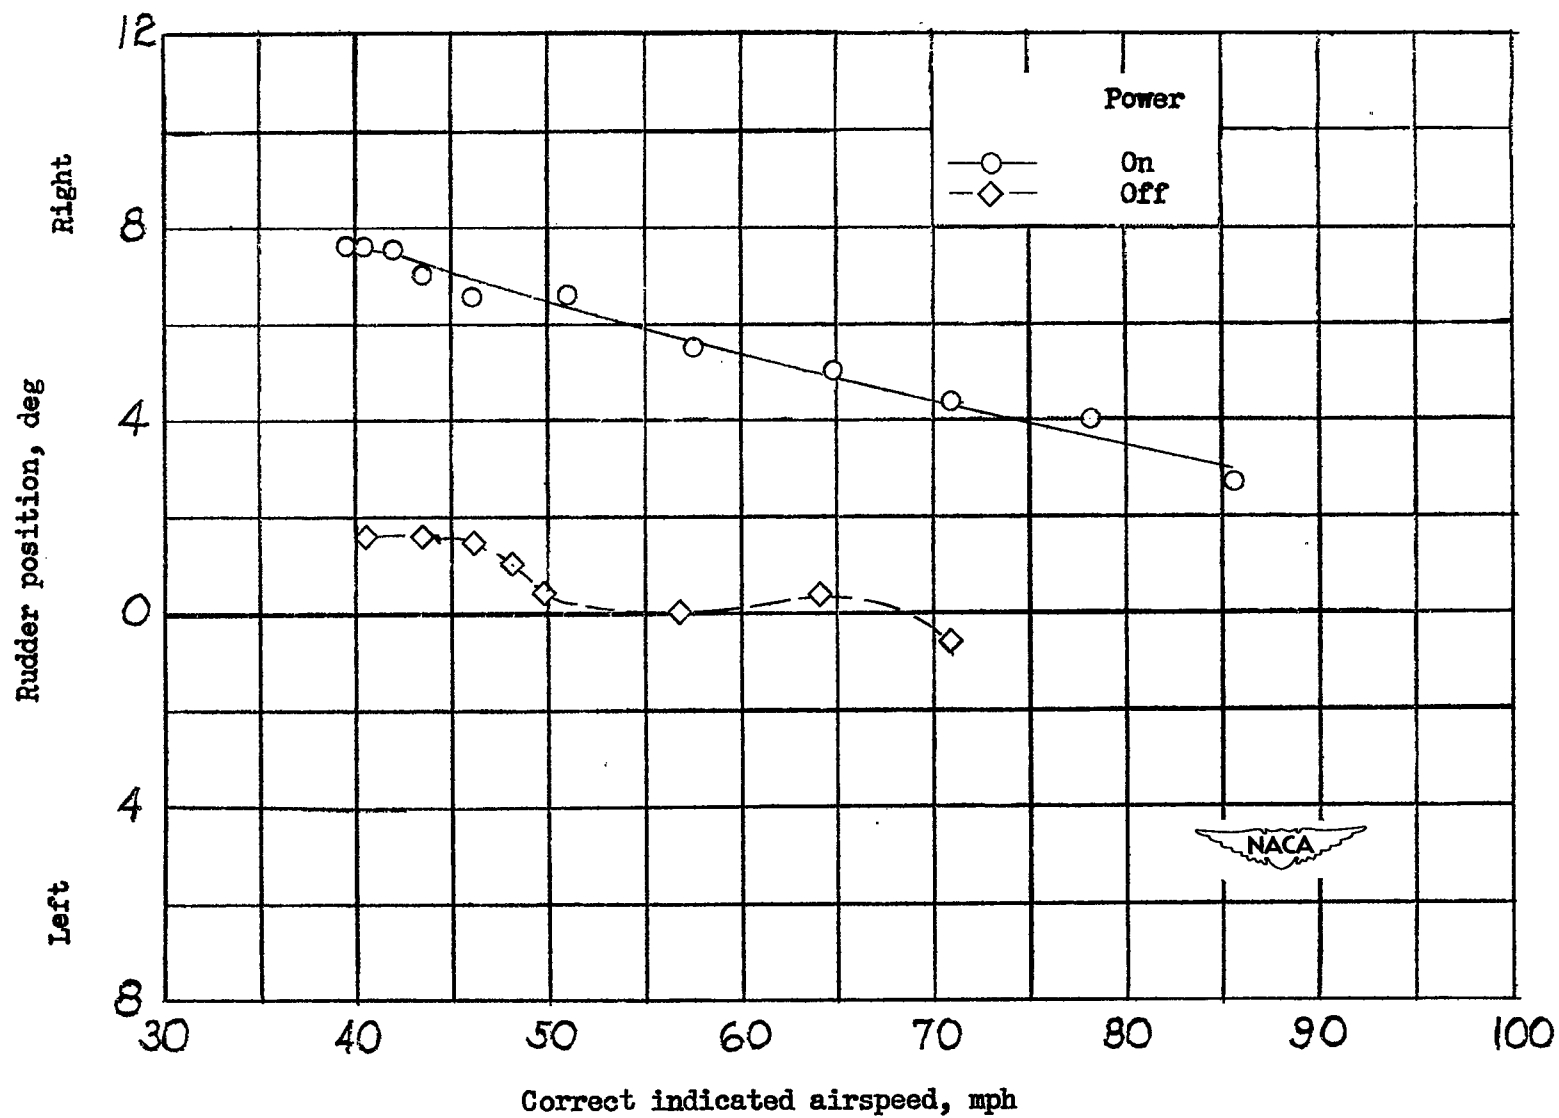
Figure 25.- Rudder positions required for straight unyawed flight at various speeds, power on and off. Elevator tab nose heavy; airplane 1.

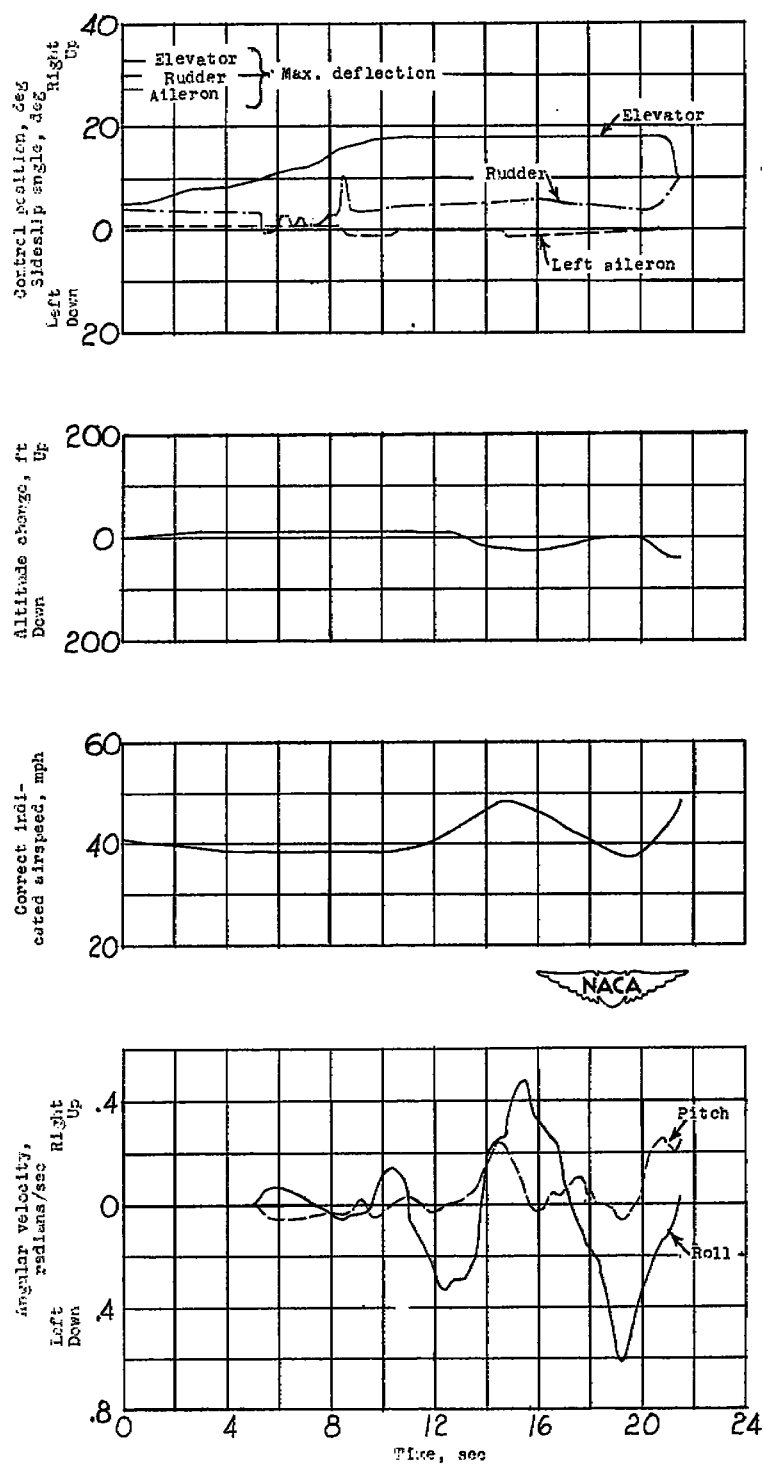
Figure 26.- Development of instability in a slowly produced laterally level power-on stall. Note rapidly diverging oscillation in roll which was not initiated by pilot. Also note the elevator position at which instability started and the pitching that originally tried to relieve stall. Full elevator was not used. Airplane 1.

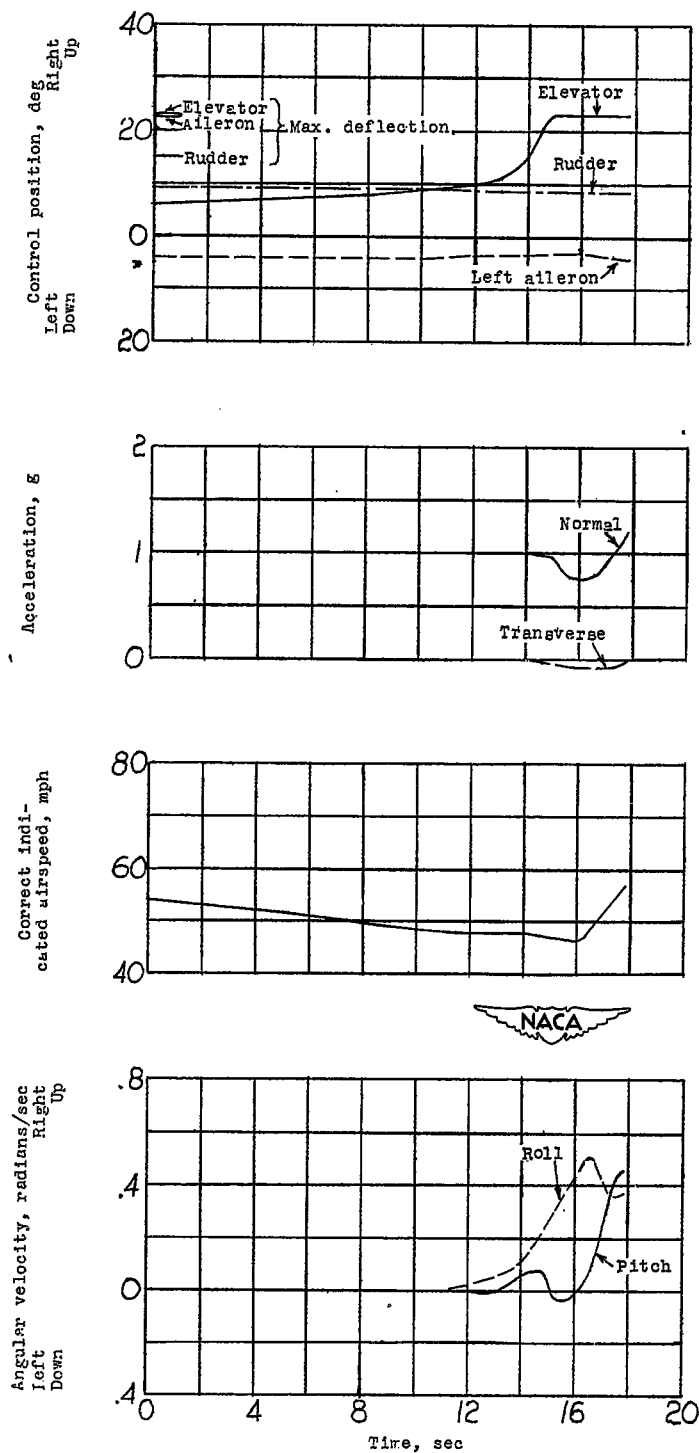
Figure 27.- Power-on stall approach from straight laterally level flight, landing gear up. Elevators were pulled up to their maximum deflection, at which point the resulting unstable motions occurred more abruptly and with somewhat more violence than with elevator held at position for slowly produced stall. Airplane 2.
